Operating Experience Weekly Summary 97-28

July 4 through July 10, 1997

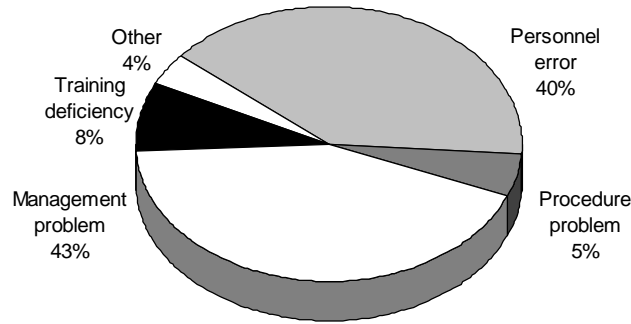
Figure 1-1. Distribution of Root Causes of Nuclear Criticality Safety Events with the Direct Cause of Procedures Not Used or Used Incorrectly¹

Operating Experience Analysis and Feedback (OEAF) engineers reviewed the Occurrence Reporting and Processing System (ORPS) database for nuclear criticality safety events caused by procedures not used or used incorrectly and found 143 events. Figure 1-1 shows the distribution of the root causes reported by facility managers for these events DOE-wide from 1990 to present. Management problems represented 43 percent of the root causes, and personnel errors represented 40 percent. Further review of management problems shows that 39 percent were caused by inadequate administrative control; 48 percent of the personnel errors were caused by inattention to detail.

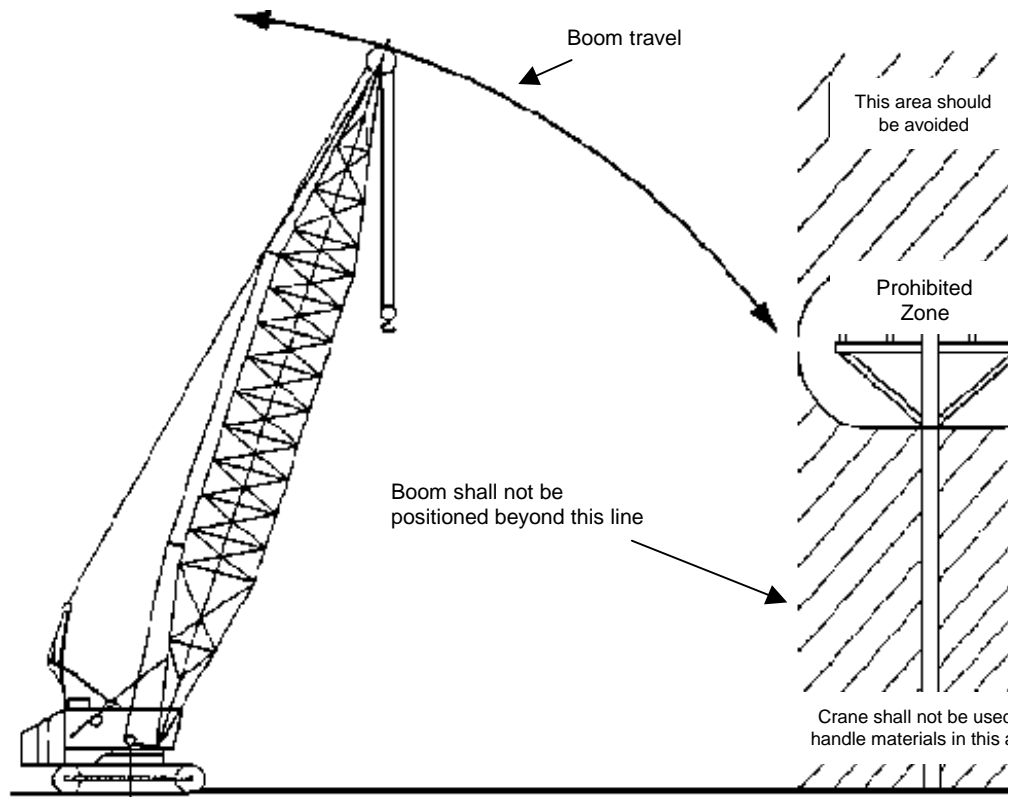
Figure 2-1. Prohibited and Danger Zones for Cranes and Lifted Loads Operating Near Electrical Transmission Lines
(Reprinted from DOE-STD-1090-96, *Hoisting and Rigging*)

On July 2, 1997, at Hanford, rigging suspended from a crane contacted an energized 13.8-kV electrical distribution line at a construction site, causing a phase-to-ground fault and loss of power to several facilities. Investigators reported that the crane operator and an oiler were preparing the crane for operation and that the boom had been left positioned above the 13.8-kV line at the end of the previous day. While looking into the rising sun, the operator attempted to lower the rigging to his line of sight for inspection. As he did so, a 12-foot choker cable attached to the rigging contacted the 13.8-kV line, causing the fault. Improper operation of the crane in a prohibited zone resulted in the loss of power to several facilities and could have caused serious personal injury. (ORPS Report RL--PHMC-KBASINS-1997-0013)

DOE-STD-1090-96, *Hoisting and Rigging*, provides guidance for operation of cranes near electrical systems. This event could have been avoided if operators had followed the requirements for safe operation near energized electrical lines provided in Section 9.5.2 of the standard. In this case, the crane was operated within a boom-length of the power line. The standard requires maintaining at least 10 feet of clearance between the power lines and the crane, load line, and load when working near 13.8 kV lines. The standard also states that any operation over electric lines, even without a load, is extremely dangerous and should be avoided. In addition, a signaler must be in constant contact with the operator when equipment is in the prohibited zone. Figure 2-1 shows the prohibited zone and danger zone for cranes operated near electrical transmission lines. Managers at DOE facilities that use mobile cranes should review Section 9.5.2 of DOE-STD-1090-96 before allowing the operation of mobile cranes near energized power lines.

Investigators reported that the Project Hanford Management Contractor suspended the operation of mobile cranes for the construction project until the contractor submits a corrective action plan. The event is still under investigation. However, it is expected that corrective actions will include designating the vertical area above and below energized electrical lines as part of a prohibited zone.

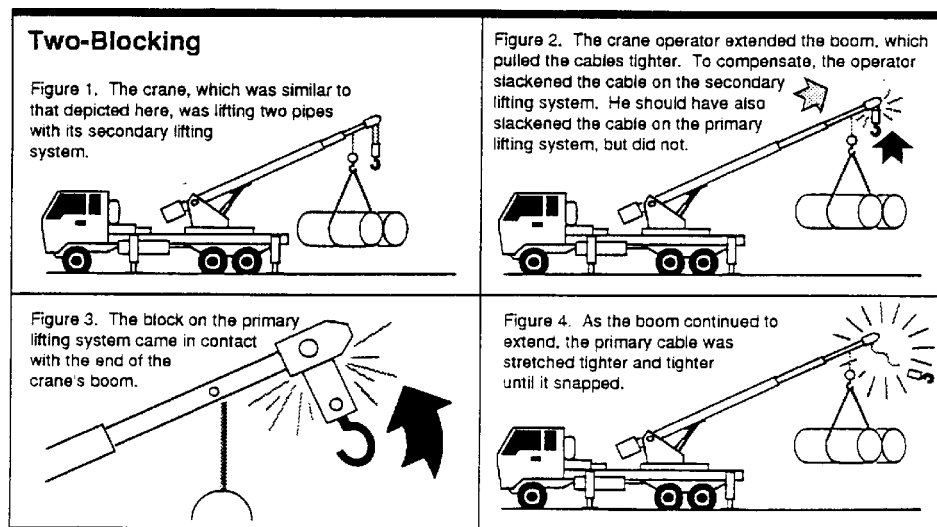
Figure 3-1. Crane Two-Blocking
(Reprinted from *Occupational Safety Observer*, November 1993, Vol. 2, No. 11)

The Office of Environment, Safety and Health reported a similar "two-blocking" incident in Volume 2, Number 11, of the *Occupational Safety Observer*. On June 23, 1993, an operator was using a crane with two lifting systems: a primary system for heavy loads and an auxiliary system for lighter loads. He was using the auxiliary system and winched the primary load block up near the top of the boom to keep it out of the way. While moving the load, the operator extended the boom. He slackened the auxiliary line to compensate, but failed to slacken the primary load line, creating the two-blocked condition. Figure 3-1 shows how this occurred.

These events could have been avoided if the individuals involved had carried out the responsibilities delineated in DOE-STD-1090-96, *Hoisting and Rigging*. The standard states that the supervisor is responsible for ensuring that equipment is operated safely, for assigning a designated leader for each lift, and for designating a person-in-charge for critical lifts. The person-in-charge or designated leader is responsible for directing the lift and stopping the job when a potentially unsafe condition is recognized. The operator is responsible for safe operation of the equipment and should not operate equipment with a known safety problem. Personnel involved in crane operations should review their responsibilities as detailed in the standard.
